M-85

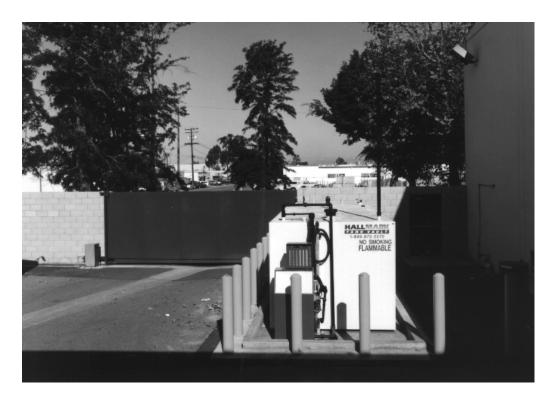
Figure 14 shows the M-85 fueling facility. Experience with this permitting process suggests that, if a fleet operator implements an alternative fuel into the fleet and plans to store the new fuel on site, local code officials may evaluate all aspects of the property, not just those pertaining specifically to the fuel itself.

Figure 14. An above-ground tank and dispenser were installed for the M-85 fueling facility.

Fuel Storage and Dispensing Equipment. Once the permit was obtained, installation of the fuel storage and dispensing equipment was relatively straightforward. The tank vendor installed the tank, fuel dispenser, and associated plumbing as part of a turn-key contract.

However, after an initial period of use, fuel contamination was noted. This was traced to several materials compatibility problems with the tank and dispenser installation. These included

- In some cases the installers had used galvanized pipe fittings rather than the required black iron fittings.
- The fuel pump and dispenser were listed by the vendor as "methanol compatible." However, this equipment turned out to be suitable only for gasoline with small amounts of methanol. The pump and dispenser unit were replaced with a more robust model from another vendor.
- The hose initially installed on the fuel dispenser was not methanol-compatible. This resulted in the carbon filler in the hose being released into the fuel. In an effort to "flush the system," the tank vendor's crew pumped contaminated fuel into the fuel tank.

After this hose and the dispenser were replaced, the tank was pumped, cleaned, and then put back into service.
